YOUR ONESURVEY
HOME REPORT

31 Anderson Drive
Saltcoats
KA21 6AS

Single Survey

Date of Inspection	17/11/2025
---------------------------	------------

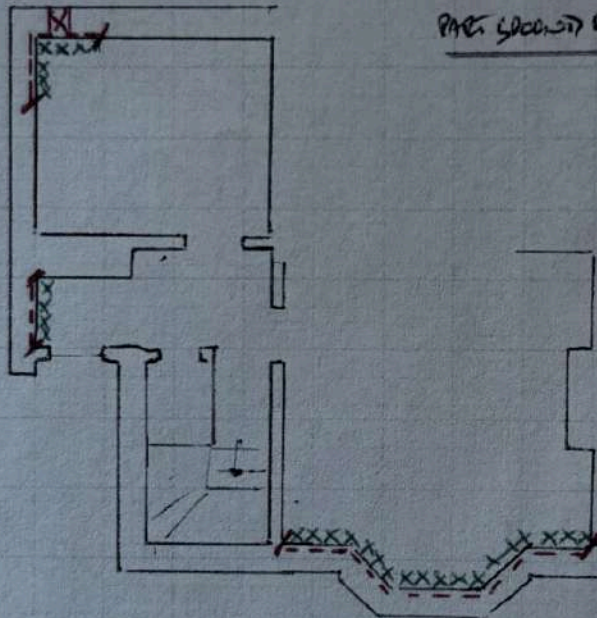
PART SPECIFIED FLOOR PLAN

XXX MEMBRANE + PADDED
APPROX 1.0- 1.15M

☒ PASSIVE VENT AT THIS LEVEL
