YOUR ONESURVEY
HOME REPORT

29 Kilmeny Court
Ardrossan
KA22 8DJ

SINGLE SURVEY

Surveyor Reference	SB/0050
Customer	Ms. Anita Paul
Selling address	29 Kilmeny Court Ardrossan KA22 8DJ
Date of Inspection	10/06/2026
Prepared by	Nick Davis, MSc MRICS Saltcoats - Allied Surveyors Scotland Ltd

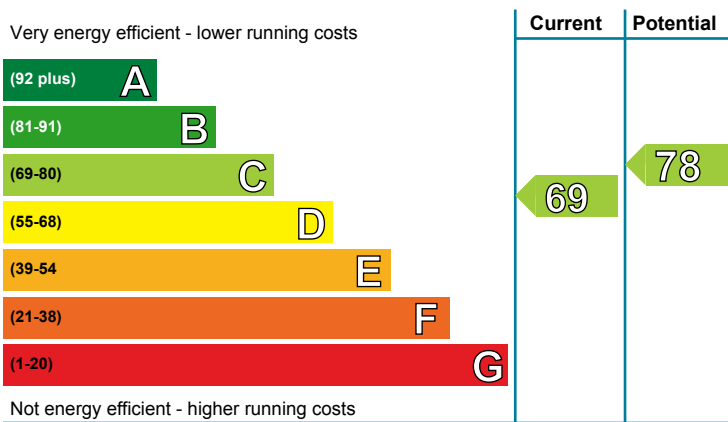
Energy Efficiency Rating

This graph shows the current efficiency of your home, taking into account both energy efficiency and fuel costs. The higher this rating, the lower your fuel bills are likely to be.

Your current rating is **band C (69)**. The average rating for EPCs in Scotland is **band D (61)**.

Recommended measures	Indicative cost	Typical savings over 3 years
1 Increase hot water cylinder insulation	£20 - £40	£186.00
2 High heat retention storage heaters	£1,200 - £2,400	£966.00

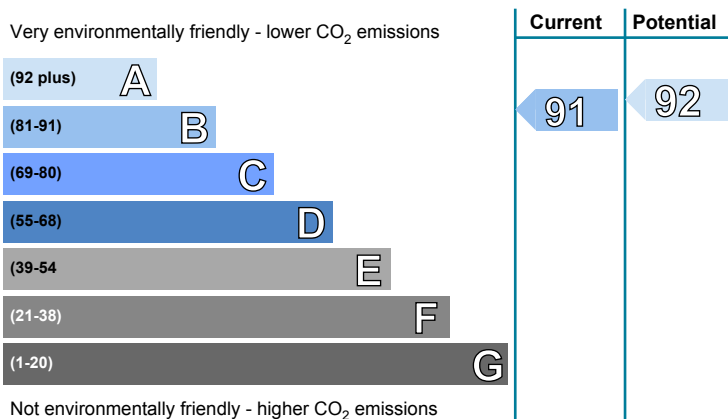
Environmental Impact (CO₂) Rating

This graph shows the effect of your home on the environment in terms of carbon dioxide (CO₂) emissions. The higher the rating, the less impact it has on the environment.
