Home Report

7 Pladda Road
Saltcoats KA21 6AF

Single Survey

Property Address	7 Pladda Road Saltcoats KA21 6AF
Customer	Mr Colin Millar
Prepared by	Graham + Sbbald LLP
Date of Inspection	06/03/2025

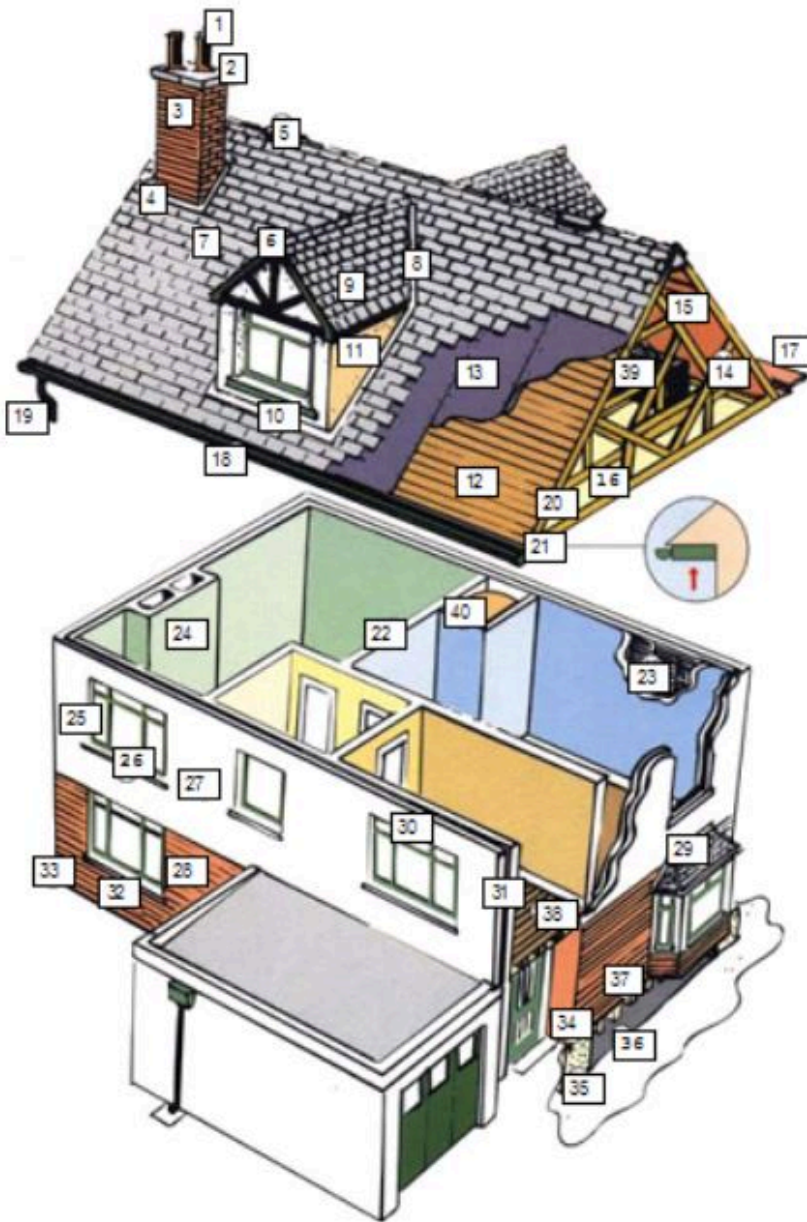
Sectional diagram showing elements of a typical house

1	Chimney pots
2	Coping stone
3	Chimney head
4	Flashing
5	Ridge ventilation
6	Ridge board
7	Slates/ tiles
8	Valley guttering
9	Dormer projection
10	Dormer flashing
11	Dormer cheeks
12	Sarking
13	Roof felt
14	Trusses
15	Collar
16	Insulation
17	Parapet gutter
18	Eaves guttering
19	Rainwater downpipe
20	Verge boards/ skewes
21	Soffit boards
22	Partition wall
23	Lath / plaster
24	Chimney breast
25	Window pointing
26	Window sills
27	Rendering
28	Brickwork / pointing
29	Bay window projection
30	Lintels
31	Cavity walls/ wall ties
32	Subfloor ventilator
33	Damp proof course
34	Base course
35	Foundations
36	Solum
37	Floor joists
38	Floorboards
39	Water tank
40	Hot water tank

Reference may be made in this report to some or all of the above component parts of the property. This diagram may assist you in locating and understanding these items.
