Home Report

63 Byres Road
Kilwinning KA13 6JU

Single Survey

Property Address	63 Byres Road Kilwinning KA13 6JU
Customer	Jim Muir
Prepared by	Graham + Sibbald LLP
Date of Inspection	04/07/2025

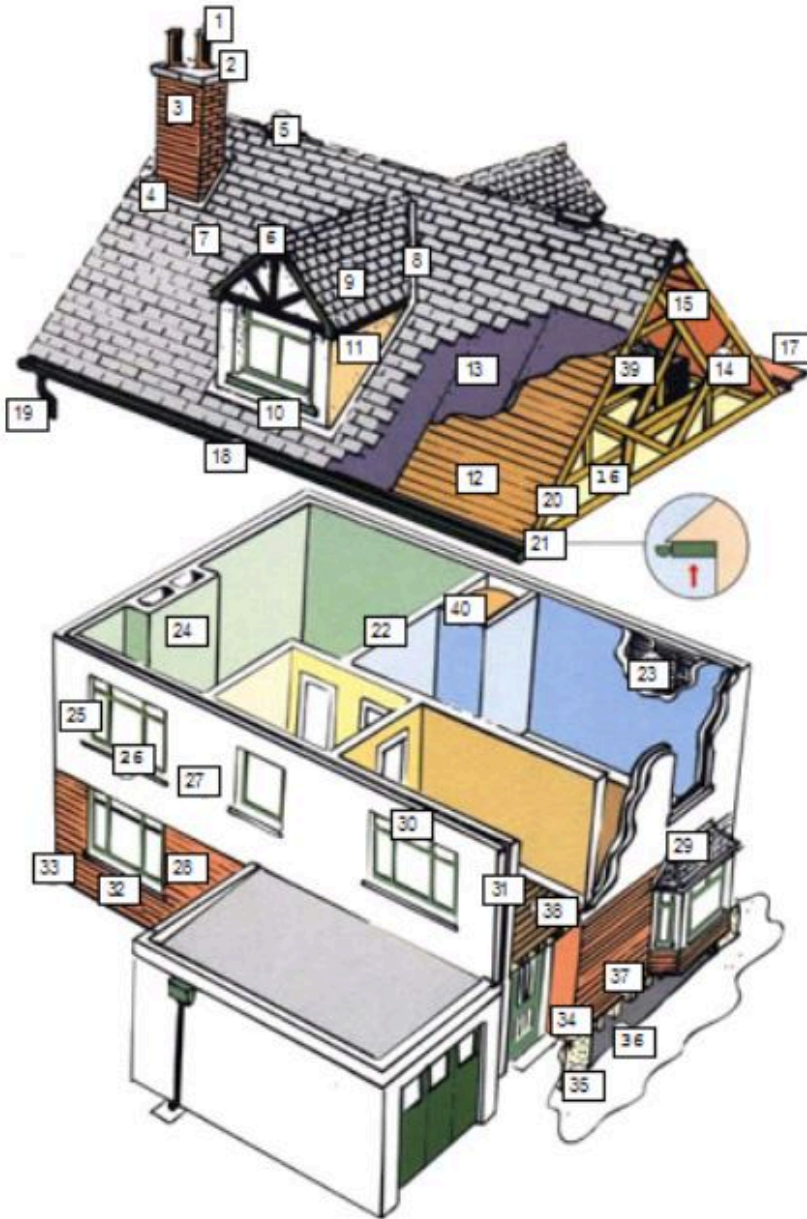
Sectional diagram showing elements of a typical house

1	Chimney pots
2	Coping stone
3	Chimney head
4	Flashing
5	Ridge ventilation
6	Ridge board
7	Slates/ tiles
8	Valley guttering
9	Dormer projection
10	Dormer flashing
11	Dormer cheeks
12	Sarking
13	Roof felt
14	Trusses
15	Collar
16	Insulation
17	Parapet gutter
18	Eaves guttering
19	Rainwater downpipe
20	Verge boards/ skewes
21	Soffit boards
22	Partition wall
23	Lath / plaster
24	Chimney breast
25	Window pointing
26	Window sills
27	Pendering
28	Brickwork / pointing
29	Bay window projection
30	Lintels
31	Cavity walls/ wall ties
32	Subfloor ventilator
33	Damp proof course
34	Base course
35	Foundations
36	Solum
37	Floor joists
38	Floorboards
39	Water tank
40	Hot water tank

Reference may be made in this report to some or all of the above component parts of the property. This diagram may assist you in locating and understanding these items.

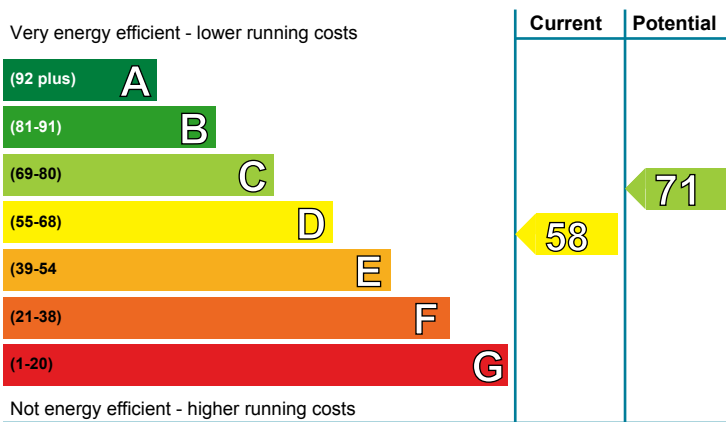
Energy Efficiency Rating

This graph shows the current efficiency of your home, taking into account both energy efficiency and fuel costs. The higher this rating, the lower your fuel bills are likely to be.

Your current rating is **band D (58)**. The average rating for EPCs in Scotland is **band D (61)**.

The potential rating shows the effect of undertaking all of the improvement measures listed within your recommendations report.
