YOUR ONESURVEY
HOME REPORT

17 St. Johns Place
Ardrossan
KA22 8HN

SINGLE SURVEY

Single Survey

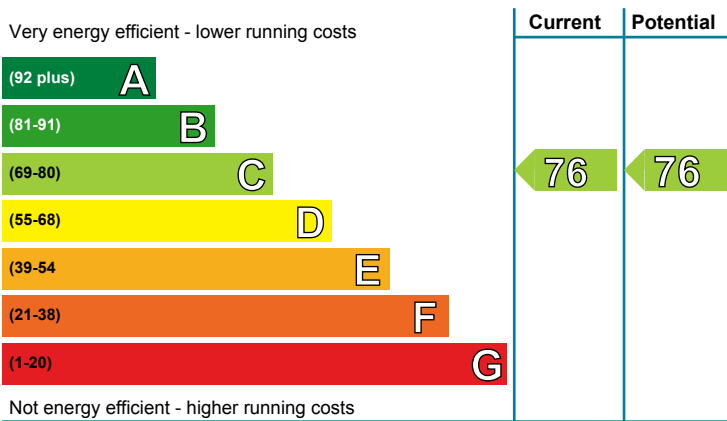
Energy Efficiency Rating

This graph shows the current efficiency of your home, taking into account both energy efficiency and fuel costs. The higher this rating, the lower your fuel bills are likely to be.

Your current rating is **band C (76)**. The average rating for EPCs in Scotland is **band D (61)**.

The potential rating shows the effect of undertaking all of the improvement measures listed within your recommendations report.

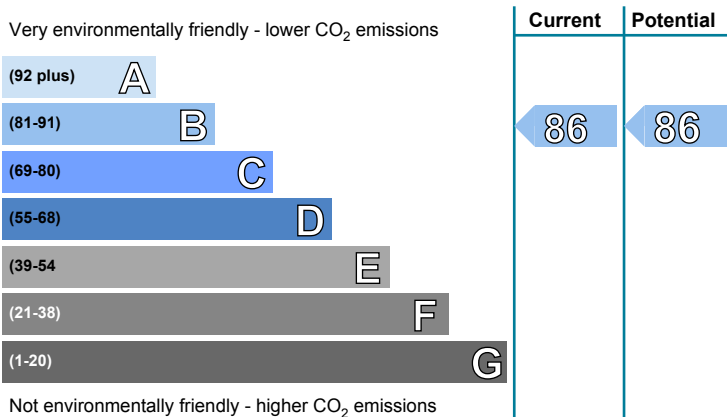
Environmental Impact (CO₂) Rating

This graph shows the effect of your home on the environment in terms of carbon dioxide (CO₂) emissions. The higher the rating, the less impact it has on the environment.
