YOUR ONESURVEY  
**HOME REPORT**

90 Barrie Terrace  
Ardrossan  
KA22 8BA

# SINGLE SURVEY

# Single Survey

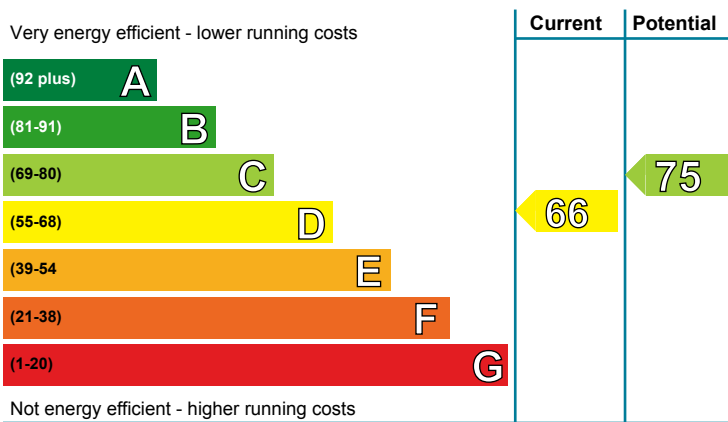
## Energy Efficiency Rating

This graph shows the current efficiency of your home, taking into account both energy efficiency and fuel costs. The higher this rating, the lower your fuel bills are likely to be.

Your current rating is **band D (66)**. The average rating for EPCs in Scotland is **band D (61)**.

The potential rating shows the effect of undertaking all of the improvement measures listed within your recommendations report.

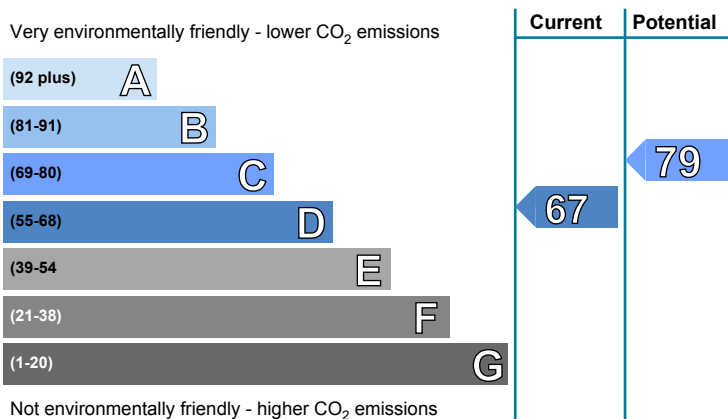
## Environmental Impact (CO<sub>2</sub>) Rating

This graph shows the effect of your home on the environment in terms of carbon dioxide (CO<sub>2</sub>) emissions. The higher the rating, the less impact it has on the environment.
