YOUR ONESURVEY
HOME REPORT

12 Laighdykes Road
Saltcoats
KA21 5TQ

Single Survey

Surveyor Reference	SA/9766
Customer	Mr. Gordon Porter
Selling address	12 Laighdykes Road Saltcoats KA21 5TQ
Date of Inspection	13/11/2025
Prepared by	Nick Davis, MSc MRICS Saltcoats - Allied Surveyors Scotland Ltd

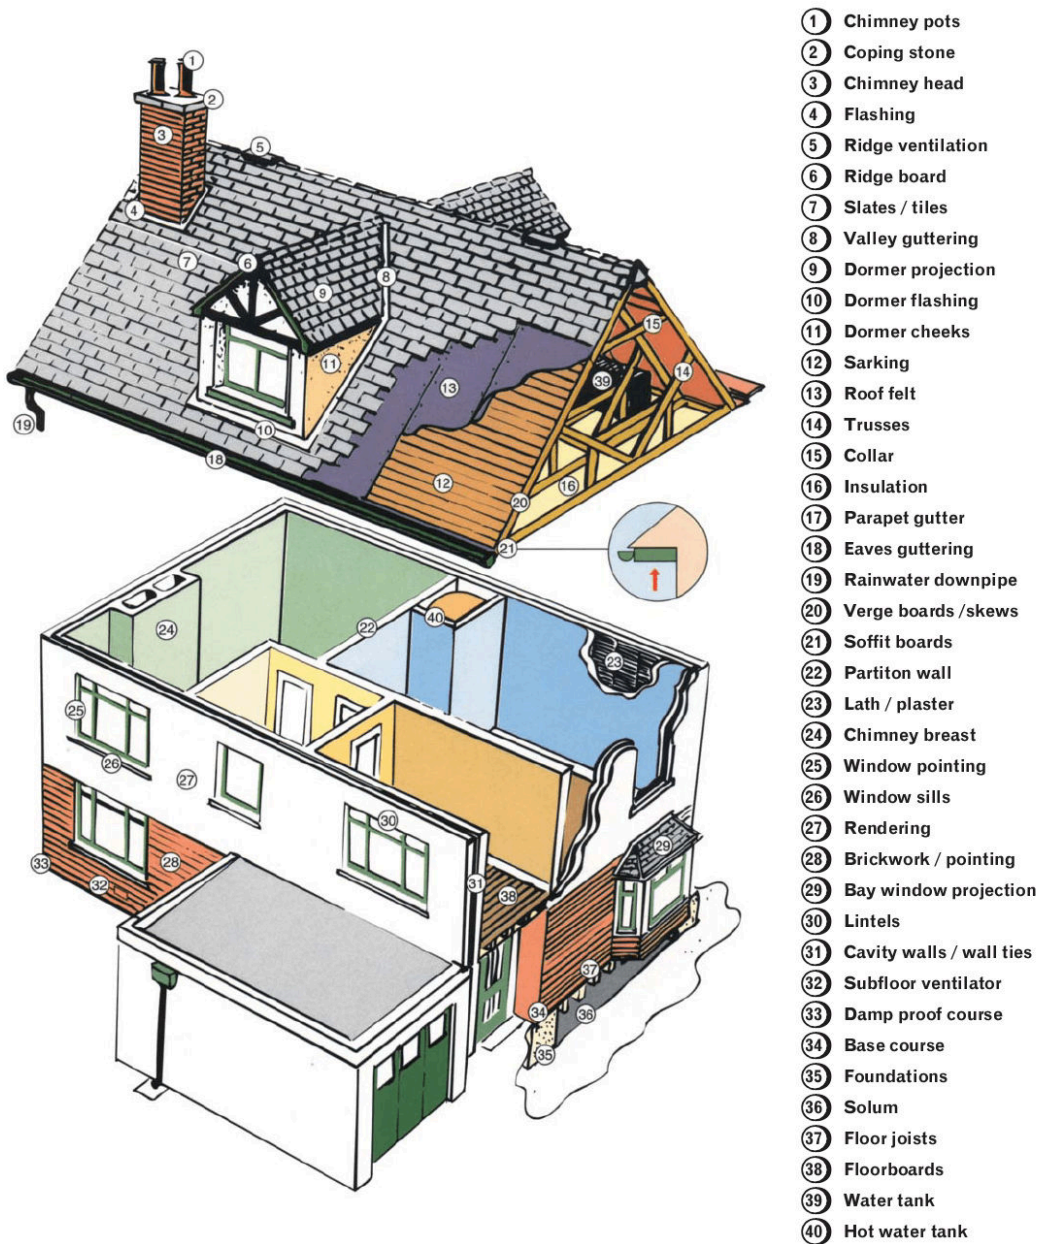
Sectional Diagram showing elements of a typical house

Reference may be made in this report to some or all of the above component parts of the property. This diagram may assist you in locating and understanding these items.

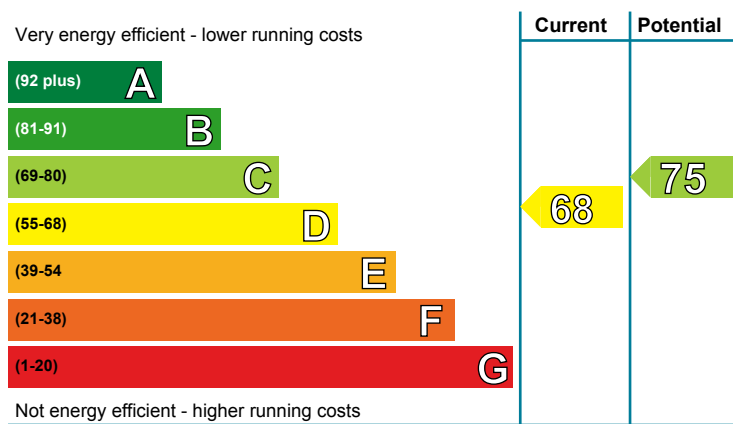
Energy Efficiency Rating

This graph shows the current efficiency of your home, taking into account both energy efficiency and fuel costs. The higher this rating, the lower your fuel bills are likely to be.

Your current rating is **band D (68)**. The average rating for EPCs in Scotland is **band D (61)**.

The potential rating shows the effect of undertaking all of the improvement measures listed within your recommendations report.

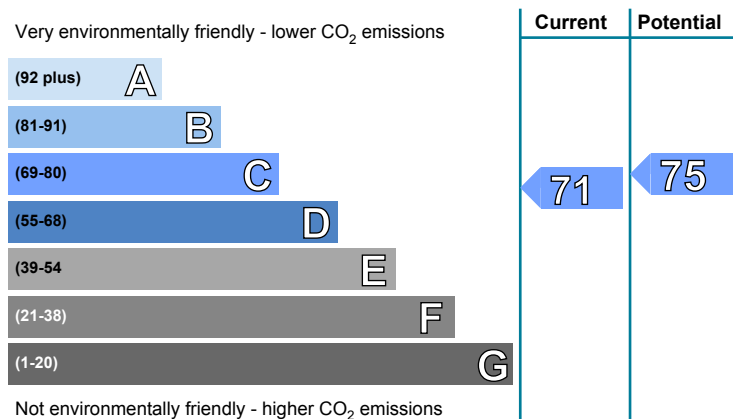
Environmental Impact (CO₂) Rating

This graph shows the effect of your home on the environment in terms of carbon dioxide (CO₂) emissions. The higher the rating, the less impact it has on the environment.
