YOUR ONESURVEY  
**HOME REPORT**

6 John Brogan Place  
Stevenston  
KA20 3ED

# Single Survey

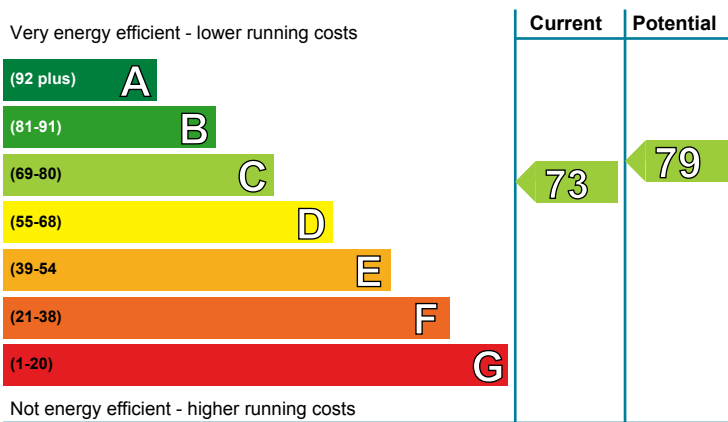
## Energy Efficiency Rating

This graph shows the current efficiency of your home, taking into account both energy efficiency and fuel costs. The higher this rating, the lower your fuel bills are likely to be.

Your current rating is **band C (73)**. The average rating for EPCs in Scotland is **band D (61)**.

The potential rating shows the effect of undertaking all of the improvement measures listed within your recommendations report.

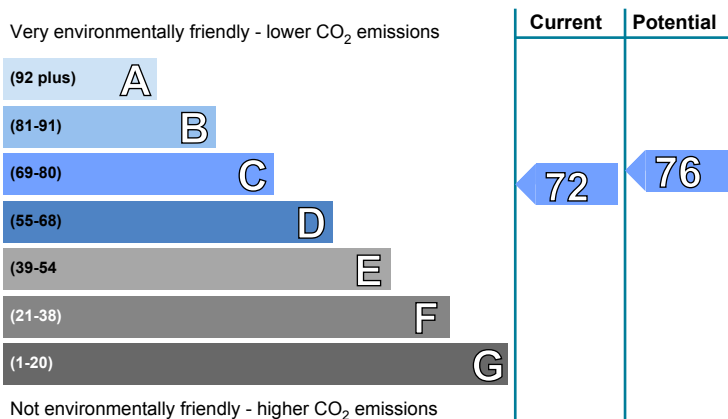
## Environmental Impact (CO<sub>2</sub>) Rating

This graph shows the effect of your home on the environment in terms of carbon dioxide (CO<sub>2</sub>) emissions. The higher the rating, the less impact it has on the environment.
