YOUR ONESURVEY
HOME REPORT

Flat C
83 Main Road
Crookedholm, Kilmarnock
KA3 6JU

SINGLE SURVEY

Single Survey

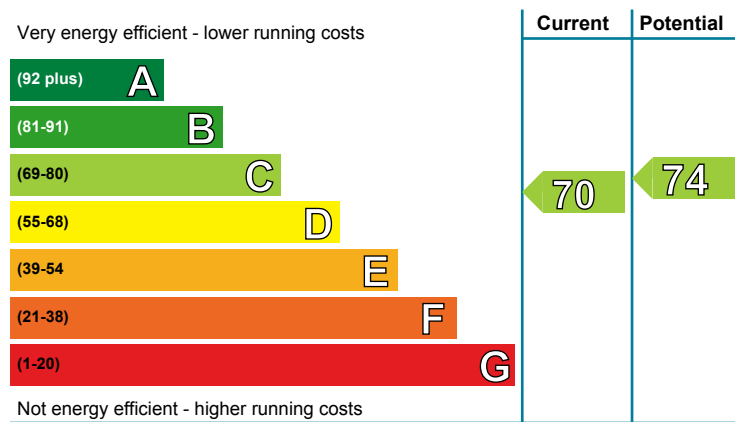
Energy Efficiency Rating

This graph shows the current efficiency of your home, taking into account both energy efficiency and fuel costs. The higher this rating, the lower your fuel bills are likely to be.

Your current rating is **band C (70)**. The average rating for EPCs in Scotland is **band D (61)**.

The potential rating shows the effect of undertaking all of the improvement measures listed within your recommendations report.

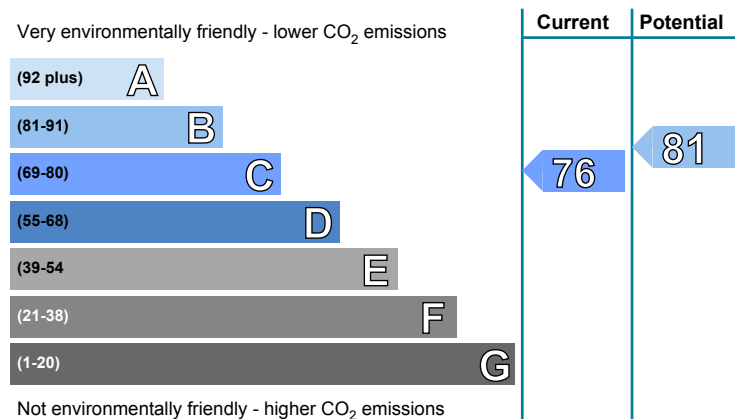
Environmental Impact (CO₂) Rating

This graph shows the effect of your home on the environment in terms of carbon dioxide (CO₂) emissions. The higher the rating, the less impact it has on the environment.
