YOUR ONESURVEY  
**HOME REPORT**

10 Carmel Terrace  
Kilmarnock  
KA1 2PB

# SINGLE SURVEY

# Single Survey

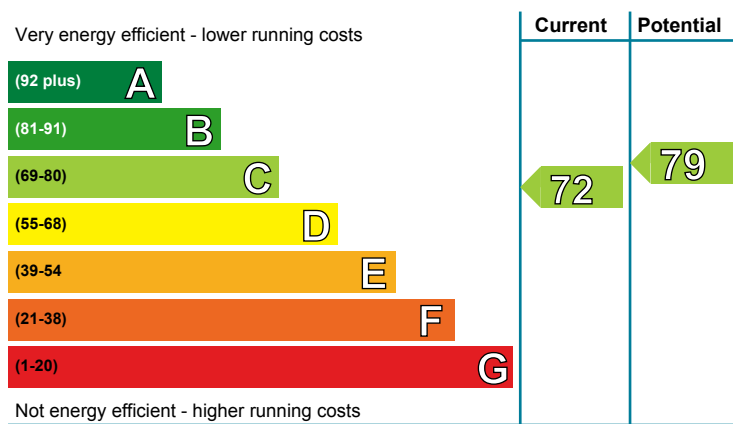
## Energy Efficiency Rating

This graph shows the current efficiency of your home, taking into account both energy efficiency and fuel costs. The higher this rating, the lower your fuel bills are likely to be.

Your current rating is **band C (72)**. The average rating for EPCs in Scotland is **band D (61)**.

The potential rating shows the effect of undertaking all of the improvement measures listed within your recommendations report.

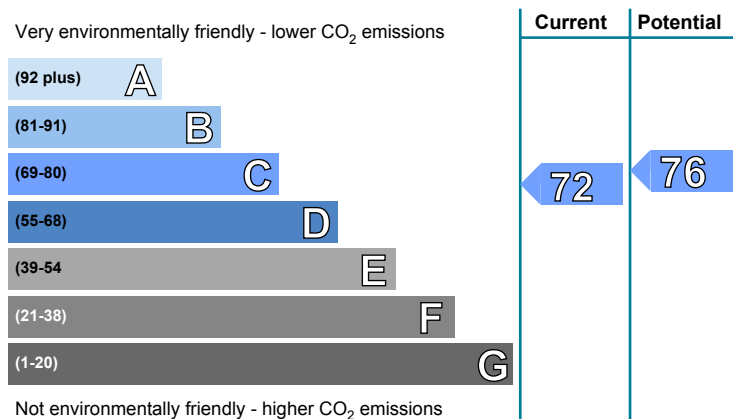
## Environmental Impact (CO<sub>2</sub>) Rating

This graph shows the effect of your home on the environment in terms of carbon dioxide (CO<sub>2</sub>) emissions. The higher the rating, the less impact it has on the environment.
