YOUR ONESURVEY  
**HOME REPORT**

83 Glenriddet Avenue  
Kilbirnie  
KA25 6LL

# SINGLE SURVEY

A report on the condition of the property, with categories being rated from 1 to 3.

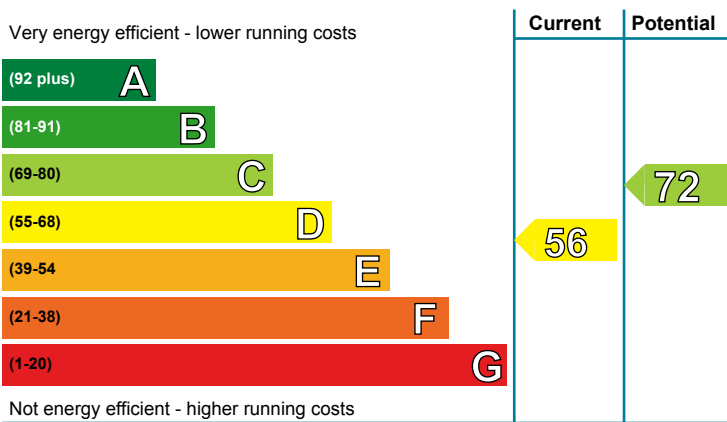
## Energy Efficiency Rating

This graph shows the current efficiency of your home, taking into account both energy efficiency and fuel costs. The higher this rating, the lower your fuel bills are likely to be.

Your current rating is **band D (56)**. The average rating for EPCs in Scotland is **band D (61)**.

The potential rating shows the effect of undertaking all of the improvement measures listed within your recommendations report.

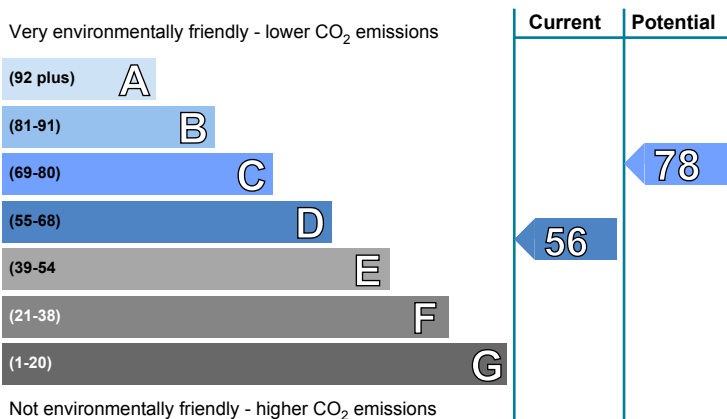
## Environmental Impact (CO<sub>2</sub>) Rating

This graph shows the effect of your home on the environment in terms of carbon dioxide (CO<sub>2</sub>) emissions. The higher the rating, the less impact it has on the environment.
