YOUR ONESURVEY
HOME REPORT

43 St. Marys Place
Saltcoats
KA21 5NY

SINGLE SURVEY

Surveyor Reference	SA/9865
Customer	Ms. Julie Wilson
Selling address	43 St. Marys Place Saltcoats KA21 5NY
Date of Inspection	13/02/2026
Prepared by	Fraser Rowand, MRICS Saltcoats - Allied Surveyors Scotland Ltd

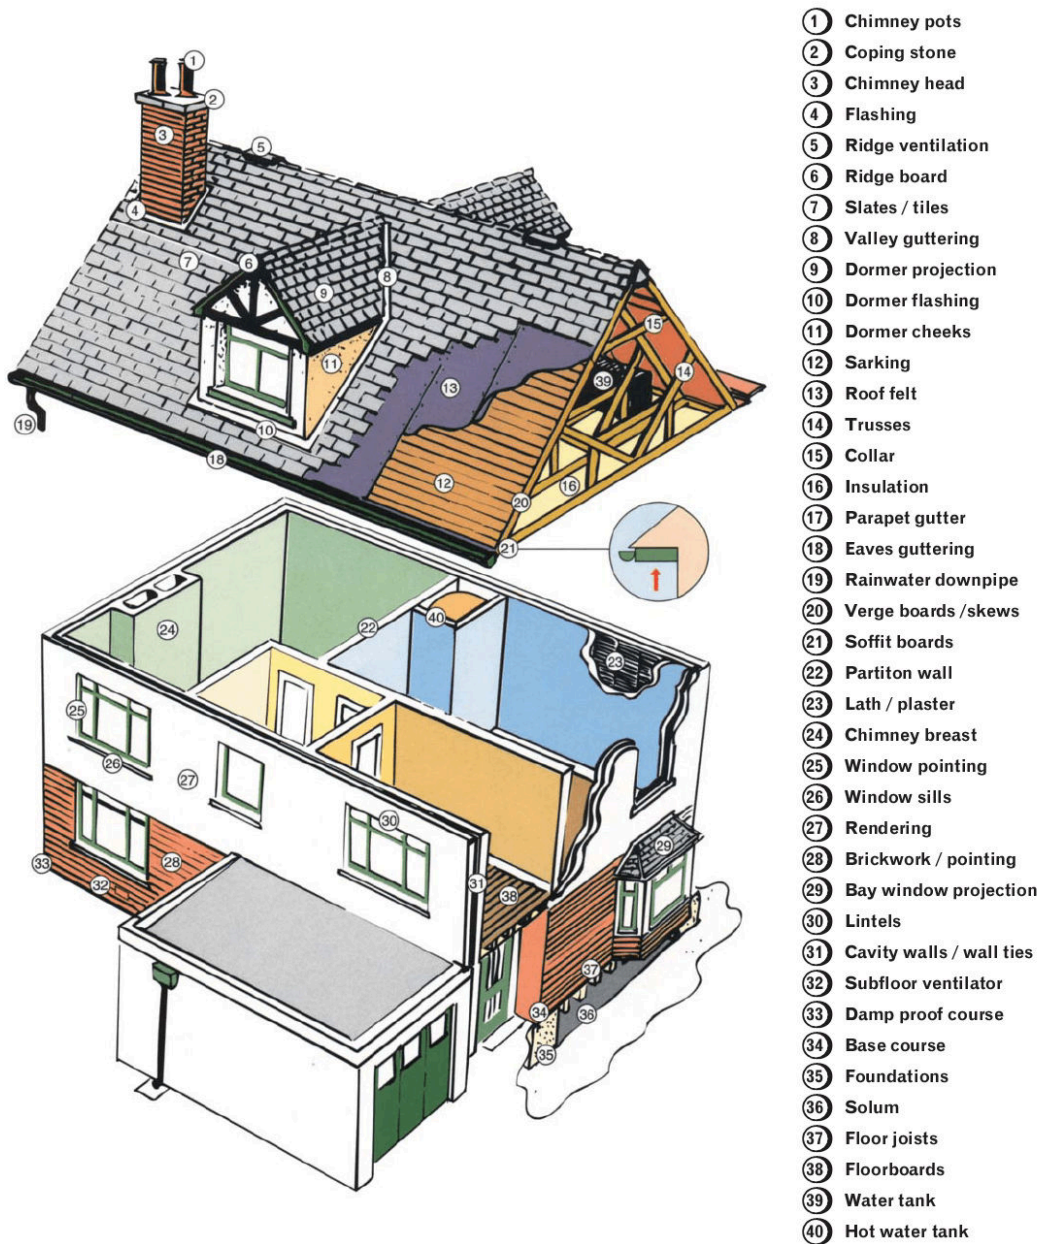
Sectional Diagram showing elements of a typical house

Reference may be made in this report to some or all of the above component parts of the property. This diagram may assist you in locating and understanding these items.
