YOUR ONESURVEY
HOME REPORT

17 Cumbrae Road
Saltcoats
KA21 6EZ

SINGLE SURVEY

Surveyor Reference	SA/9825
Executry Of	Mrs. Joyce Stalker
Selling address	17 Cumbrae Road Saltcoats KA21 6EZ
Date of Inspection	21/01/2026
Prepared by	Fraser Rowand, MRICS Saltcoats - Allied Surveyors Scotland Ltd

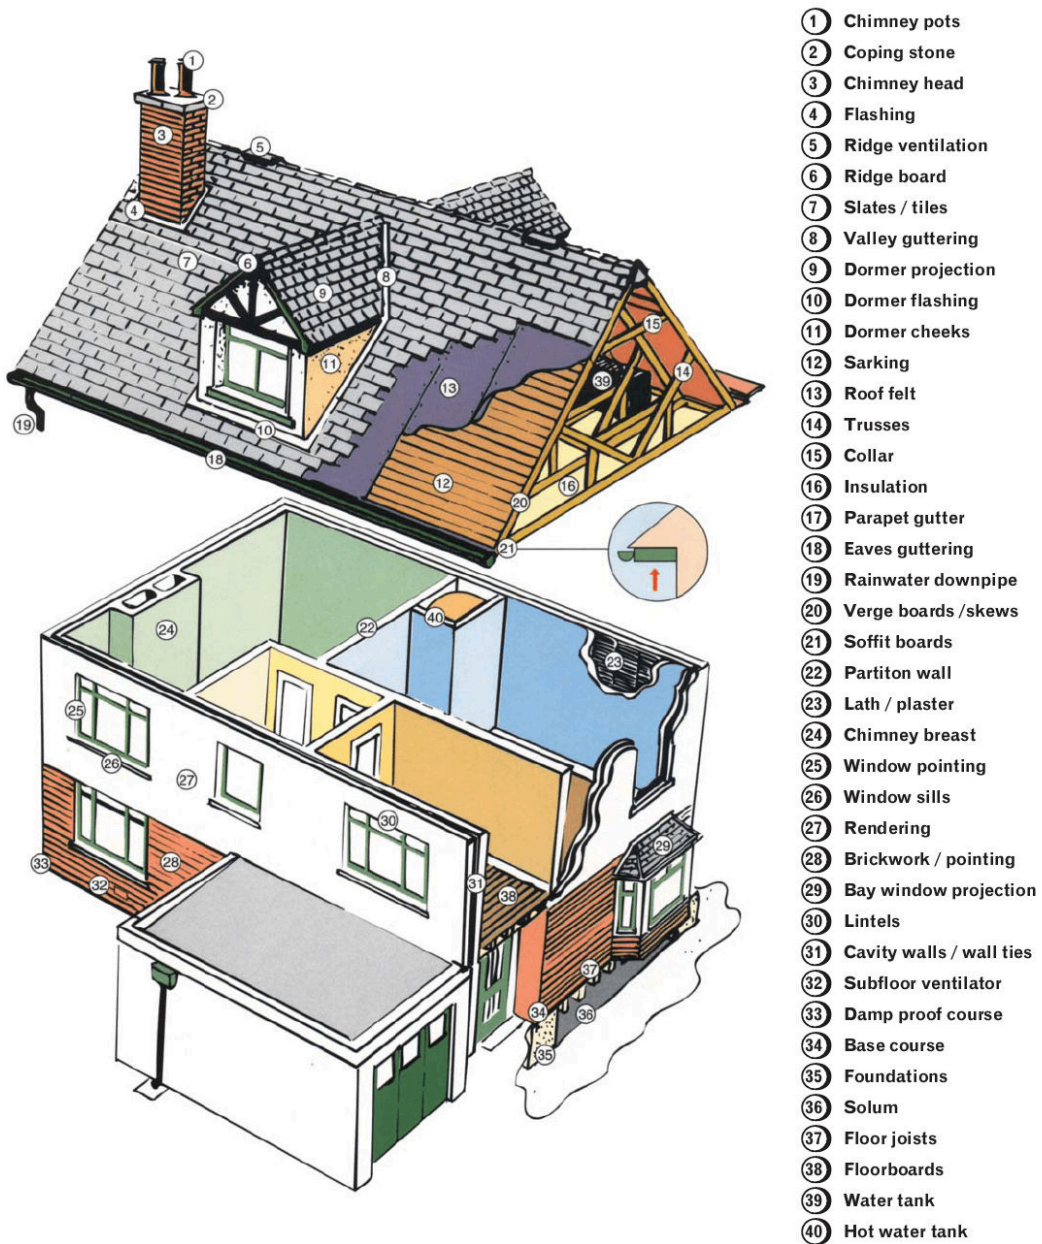
Sectional Diagram showing elements of a typical house

Reference may be made in this report to some or all of the above component parts of the property. This diagram may assist you in locating and understanding these items.

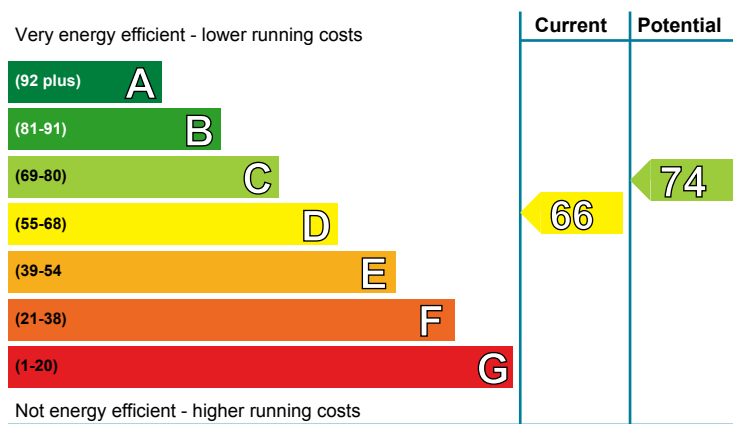
Energy Efficiency Rating

This graph shows the current efficiency of your home, taking into account both energy efficiency and fuel costs. The higher this rating, the lower your fuel bills are likely to be.

Your current rating is **band D (66)**. The average rating for EPCs in Scotland is **band D (61)**.

The potential rating shows the effect of undertaking all of the improvement measures listed within your recommendations report.

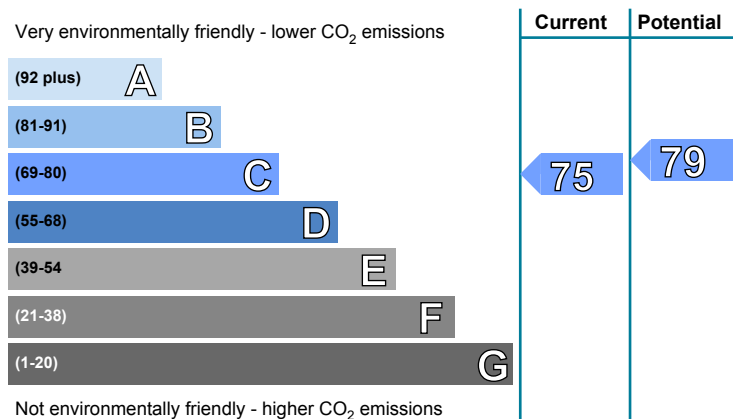
Environmental Impact (CO₂) Rating

This graph shows the effect of your home on the environment in terms of carbon dioxide (CO₂) emissions. The higher the rating, the less impact it has on the environment.
