YOUR ONESURVEY
HOME REPORT

3 Viaduct Circle
Kilwinning
KA13 7EA

SINGLE SURVEY

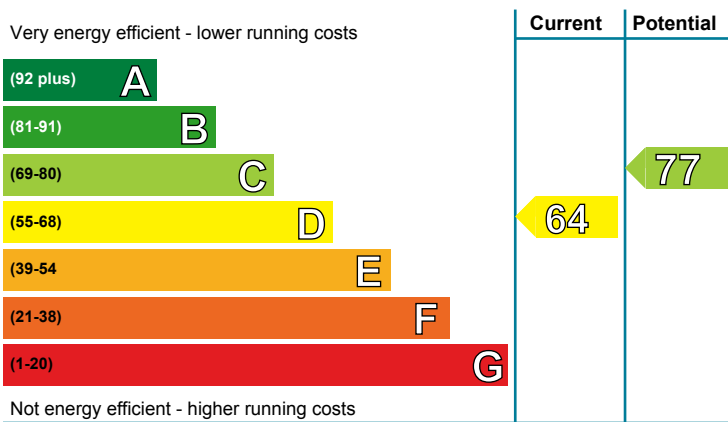
Energy Efficiency Rating

This graph shows the current efficiency of your home, taking into account both energy efficiency and fuel costs. The higher this rating, the lower your fuel bills are likely to be.

Your current rating is **band D (64)**. The average rating for EPCs in Scotland is **band D (61)**.

The potential rating shows the effect of undertaking all of the improvement measures listed within your recommendations report.
