YOUR ONESURVEY
HOME REPORT

80 Scott Road
Irvine
KA12 8EY

SINGLE SURVEY

Single Survey

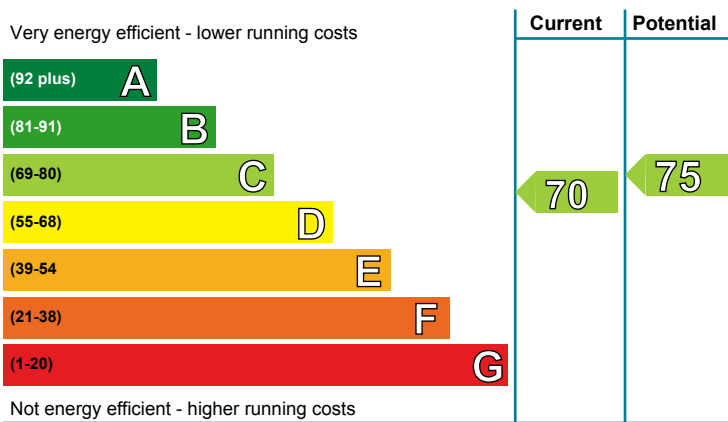
Energy Efficiency Rating

This graph shows the current efficiency of your home, taking into account both energy efficiency and fuel costs. The higher this rating, the lower your fuel bills are likely to be.

Your current rating is **band C (70)**. The average rating for EPCs in Scotland is **band D (61)**.

The potential rating shows the effect of undertaking all of the improvement measures listed within your recommendations report.

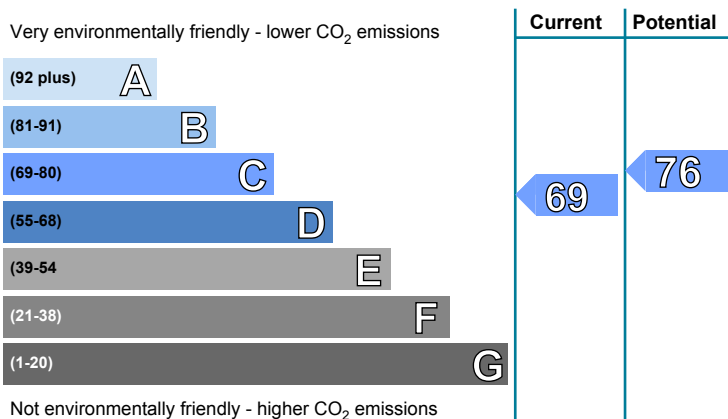
Environmental Impact (CO₂) Rating

This graph shows the effect of your home on the environment in terms of carbon dioxide (CO₂) emissions. The higher the rating, the less impact it has on the environment.
